Manhole Inspection Summary

Manhole # S27I__036MH

Insp Date: **5/30/08 8:24 AM**

Location Address: **864 W Lombard st**

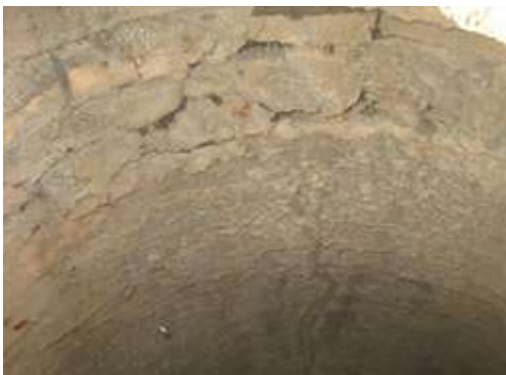
Defect 3

Infiltration: ☐ None ☒ **Joint** ☐ Cracks ☒ **Mortar** ☐ Roots ☐ Wall

Infiltration: ☐ None ☐ Joint ☐ Cracks ☒ **Mortar** ☐ Roots ☐ Wall

missing mortar infiltration in chimney frame connect as well as Corbel

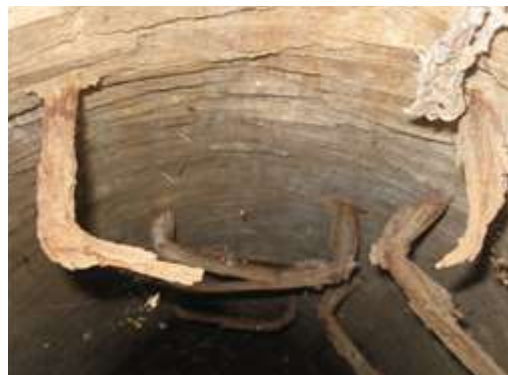
Defect 2

Count: **5** Missing: **1** ☒ **Corroded**

corroded rung and missing piece on first rungs, 4 corroded

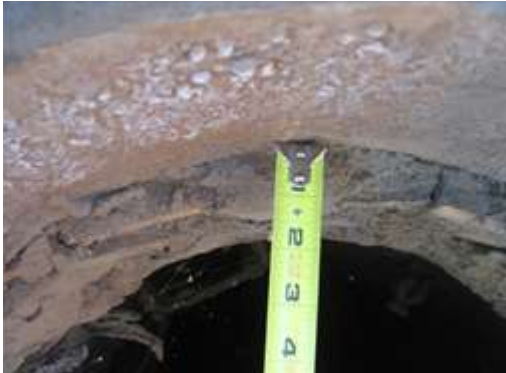
Defect 4

Offset: **1.5** (in.)

Condition: ☐ Sound ☐ Cracked ☒ **Leaks**

1.5" frame offset

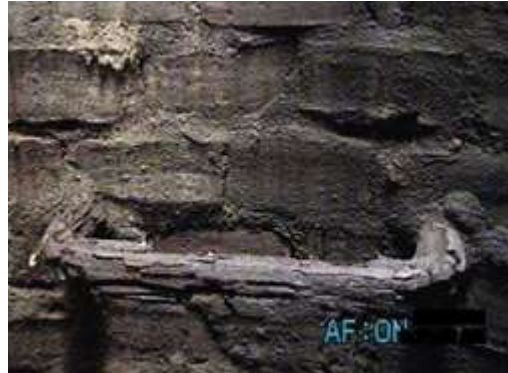
Defect 1

corroded rungs

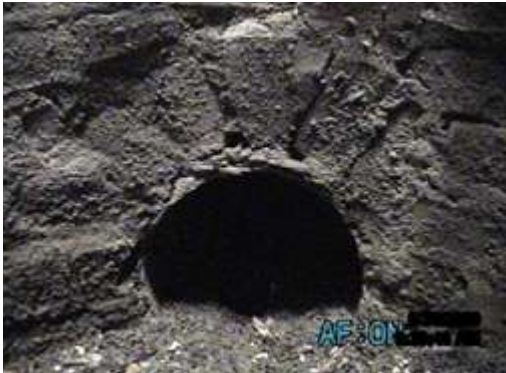
Defect 5

Condition: ☐ Sound ☐ Cracked ☐ Root Intrusion ☐ Deteriorated ☐ Leaks ☒ **Debris**

channel debris

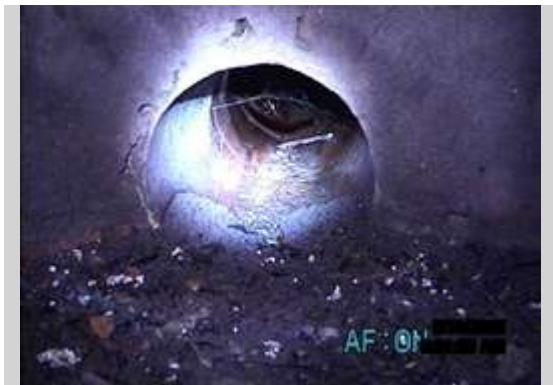
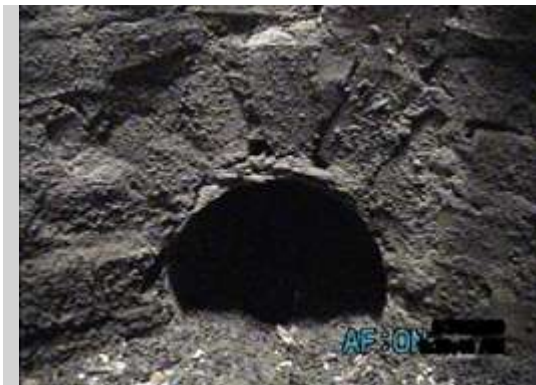
Defect 5

channel debris

Deposits: ☐ None ☐ Mud ☐ Sludge ☒ **Debris** ☐ Grease

Silt Depth: **1** (in.) Deposits Extent: **Light**
